PLANNING MALAYSIA:

VOLUME 21 ISSUE 6 (2023), Page 213 – 226

RIVERBANK PROTECTION STRUCTURE FAILURE FACTORS AND REMEDIAL APPROACH: A CASE STUDY IN KELANTAN MALAYSIA

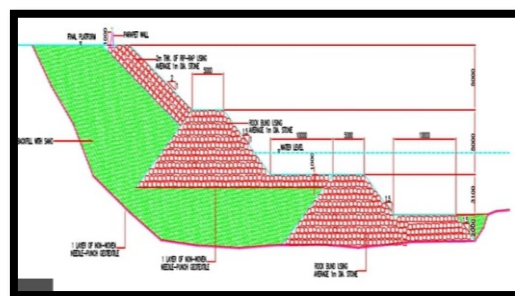
Figure 2: Rock Embankment Approach
(Malaysia Department of Irrigation, 2021)

The common remedial methods that can be used to fix problems with existing structures are examined in this article. The rock embankment that the Malaysian Department of Drainage and Irrigation (DID) built is quite stable and effective in preventing bank erosion, according to the study that was conducted.

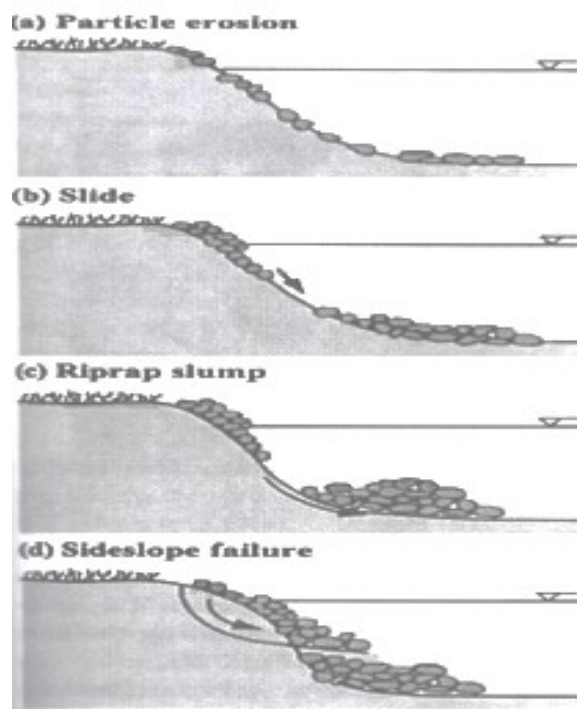
Figure 3: The Riprap Failures
(Julien, 2002)

The Kelantan River's riprap failure was classified by the National Water Research Institute of Malaysia (NAHRIM) as a sideslope failure (refer Figure 3). Instability or failure of a sloping landmass or embankment is referred to as a "sideslope failure," and it is typically characterised by the movement or sliding of soil, rock, or other materials along a sloping surface. It is a kind of slope failure that can happen on both naturally occurring slopes and slopes that have been engineered, like levees, retaining walls, or highway embankments. Additionally, debris flow was the specific cause of side slope failure in the research location. Heavy rainfall frequently results in debris flows, which is particularly important given Kelantan's monsoon season. High rainfall levels in the area during this time of year can cause increased runoff and the possibility of debris flows. The stability of the riverbanks is significantly at risk of these debris flows, which can also contribute to riverbank erosion.

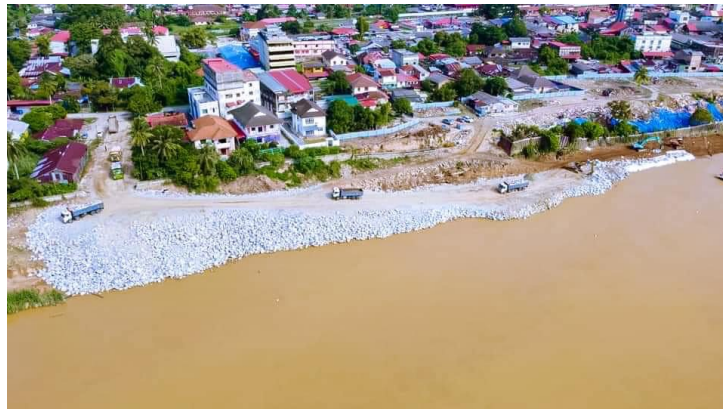
Figure 4: The Construction Progress

To make sure that the embankment is built in accordance with the design specifications, proper quality control procedures should be put in place during the construction phase. To achieve the desired stability and performance, construction methods like proper compaction, layering, and interlocking of the rock should be used. The site must be ready before construction can begin. In order to do this, the area must be cleared of all vegetation, any structures or debris must be removed, and the riverbank must be excavated to the necessary depth and slope. The stability of the embankment depends on its foundation. To achieve the needed bearing capacity, the foundation soil must be compacted. Additional precautions, such as soil stabilisation techniques, may be required if the foundation soil is fragile or unstable. Beginning at the bottom and gradually working their way up to the desired embankment height, the rocks are arranged in layers. To achieve the necessary stability, each layer is carefully positioned and compacted (refer Figure 4).
