PLANNING MALAYSIA:

VOLUME 22 ISSUE 3 (2024), Page 288 – 302

ENVIRONMENTAL MAINTENANCE APPRAISAL ON LIME-BASED MORTAR REPAIR FOR HERITAGE BUILDINGS CONSERVATION

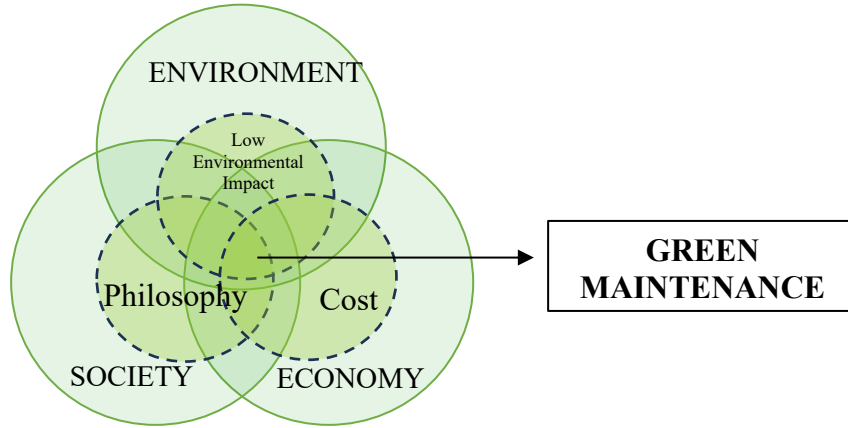
Figure 1: The Green Maintenance Model, Parameters for Evaluating the Maintenance Interventions for Heritage Buildings
 Sources: Adopted by (Kayan et al., 2017)

The Green Maintenance Model applied to support the SDGs which call for preserving the cultural significance embedded in the fabric of heritage buildings while conserving other valuable resources (Kayan et al., 2018b). The concept takes philosophical factor, cost factor, and low environmental impact factor into evaluation. The repair techniques undertaken that included the three factors in figure 1 will be considered as being the most sustainable.

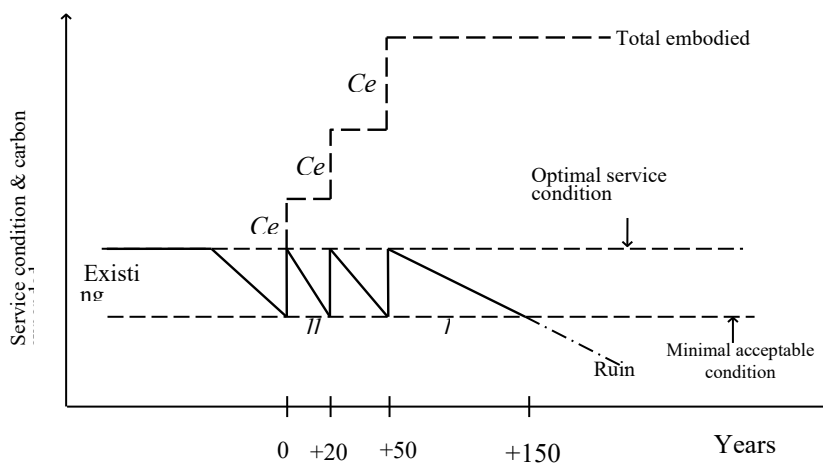
Figure 2: Relationship Between Longevity of Repair and Embodied Carbon Expenditure
 Source: (Kayan et al., 2018)

The Green Maintenance methodology addresses the relationships between CO₂ emissions and repair technique options, which offers some insight into the choice of lime-based mortar repair for heritage buildings. As proved on the service figure 2;(Kayan et al., 2018), each intervention's lifespan (l) and embodied carbon expenditure (C_e) may be used to understand how they relate to one another.

Whenever the building is in ruin stage, the building must be repaired to achieve the minimal standard and optimal service condition. Along the way the process will contribute to the cumulative total embodied carbon. The less frequency of the repair the less total cumulative embodied carbon.

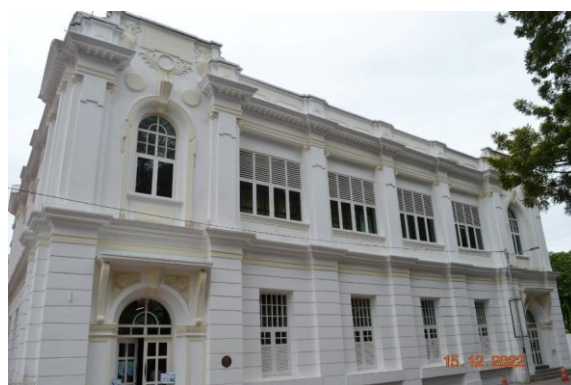
Figure 3: Hong Kong and Shanghai Bank Corporation (HSBC)

The Hong Kong and Shanghai Bank Corporation (HSBC) building on Jalan Kota was constructed as a bank during the British era and it was built around 1912. The designed on the plan rectangular symmetry. The conservation of the HSBC was in 2009 it includes repairs, and replacement of damaged elements and

structures with the same material which is lime-based mortar as the original. The major work repair of the outer wall by using lime-based mortar for the whole building. Figure 3 show the building structure of HSBC. During the conservation phase of HSBC, used of aggregates and sand were commonly rounded and contained small portions of a variety of materials such as stone dust, chalk, seashell, and ash. The proportion of binder to filler was 2:1 and 3:1.

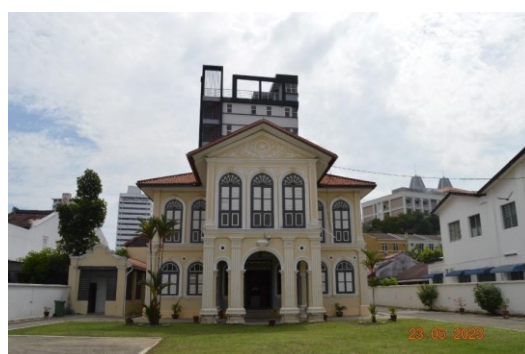
Figure 4: ‘Rumah Teh Bunga’ Building

‘Rumah Teh Bunga’ is also known as the Penang Malay Gallery, and it’s classified under the residential category. It is located at No. 138, Hutton Road, George Town, Penang. It was built in 1893 by one of the richest Jawi Peranakan, Tuan Abdul Wahab, in the late nineteenth century (Volume, 2022). The major conservation that related to the use of lime-based mortar was in 2005 that involve the whole building wall. Figure 4 show the ‘Rumah Teh Bunga’ building structure.
