**PLANNING MALAYSIA:**  
*Journal of the Malaysian Institute of Planners*  
**VOLUME 19 ISSUE 5 (2021), Page 76 – 87**

## **POST-CONSERVATION EVALUATION (PCE) ON HISTORIC BUILDINGS: AUTHENTICITY OF ADAPTIVE REUSE MUSEUMS IN GEORGE TOWN, UNESCO WORLD HERITAGE SITE**

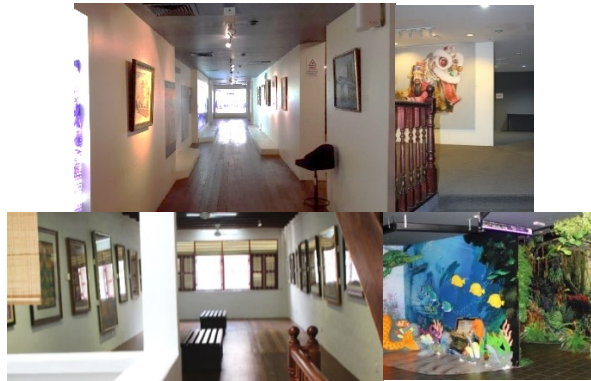
**Figure 3:** Insensitive installation of partitions, removal of original wall and extensive wall decorations were among the inappropriate physical interventions found involving internal wall element.

Overall, the three building elements that were found to be intervened inappropriately are the internal wall, windows, and building services (indicators: C, J and O). Issues inflicting these three building elements are highlighted in Figure 3, 4 and 5 to show the areas affecting authenticity of historic buildings converted to museums in George Town WHS. Physical interventions made involving the three elements clearly have direct impact on the authenticity condition of adaptive reuse museums, calling for the serious needs of adhering and respecting to design, material, workmanship and setting criteria of authenticity as stressed by ICCROM (1982).

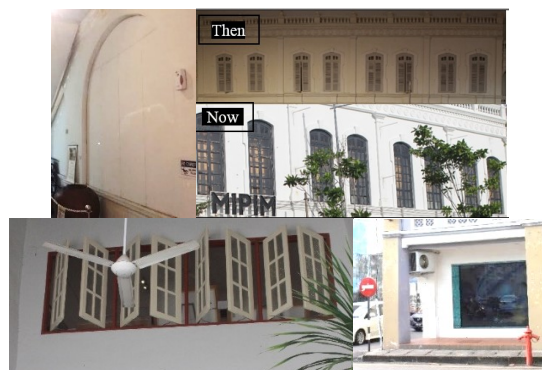
**Figure 4:** Fully enclosed original windows and replacement of non-harmonious modern windows were among the inappropriate physical interventions found on windows element.

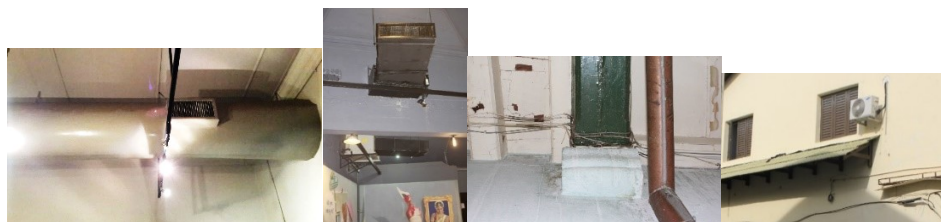
**Figure 5:** Intrusive installations, exposed electrical wiring and improper placement of air-conditioner compressors on building façade were among the inappropriate physical interventions found on building services element.
